**Docket No. 217 – Development and Management Plan Inspection**

**Norwalk Substation**

**Date:** September 7, 2006

### Plumtree Substation

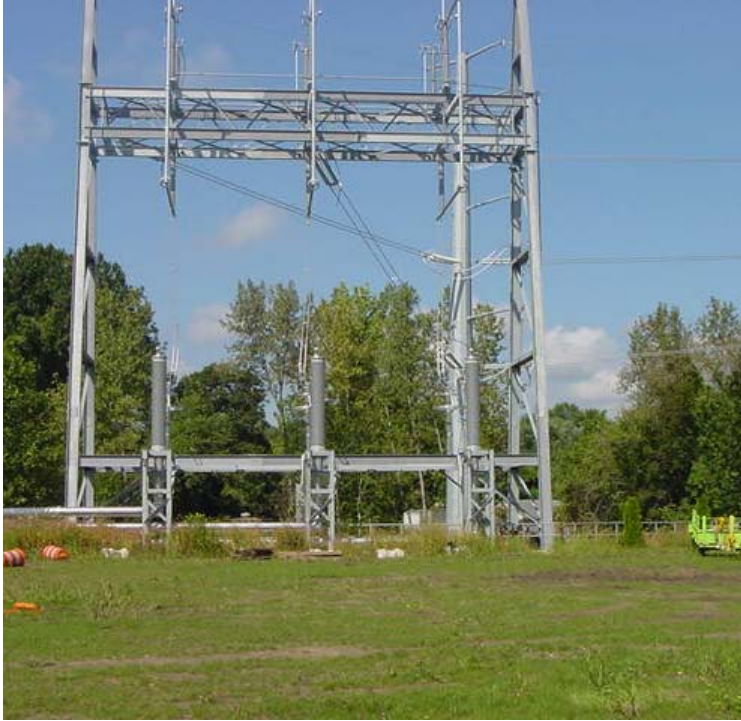
(Norwalk Substation): Photo on the left shows a view of the northern structures with wire pulled in. The adjacent landscaped areas have good grass growth. Photo on the right shows the overflow channel, fully vegetated. 9/7/06

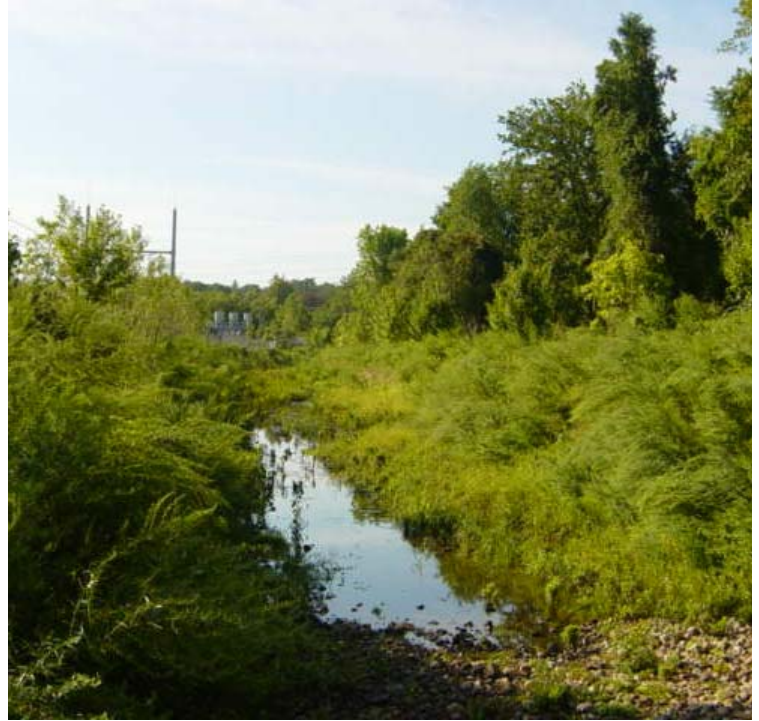
Inland Wetland and Watercourse encroachment and mitigation	- The original overflow channel is fully vegetated. 9/7/06.	- None at this time. 9/7/06.	-N/A

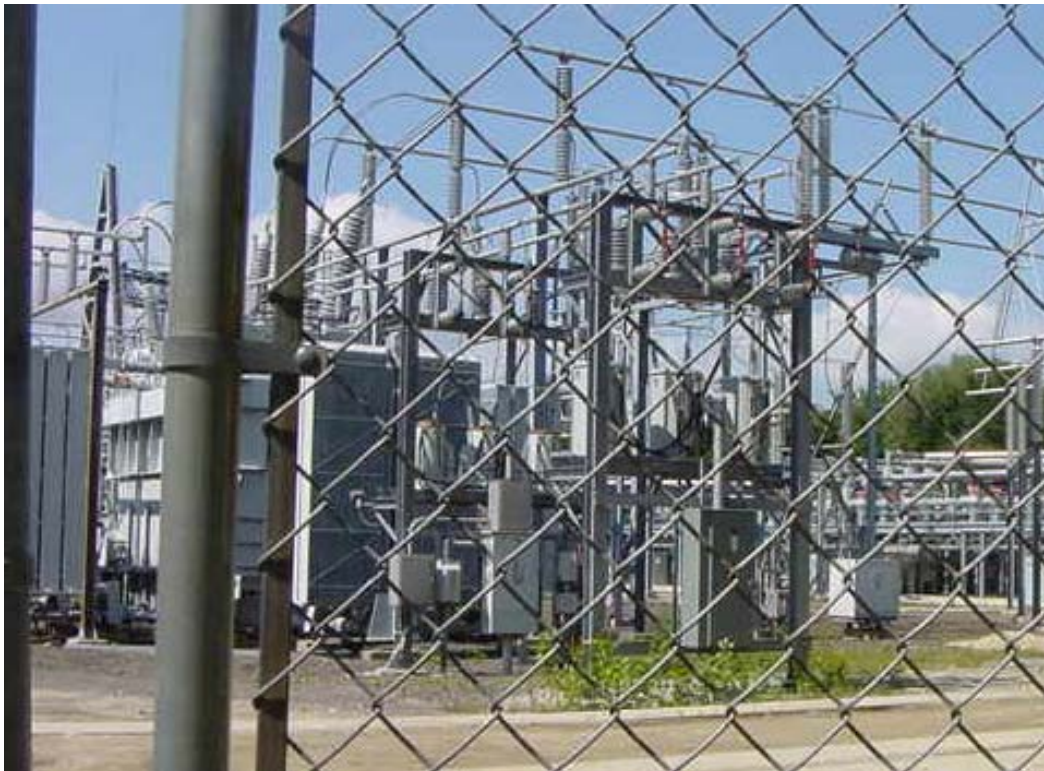
(Plumtree Substation): Photo shows a current views of the yard. 9/7/06
